## MAC-SEAL - Leak Sealing Solution

*“Successful VR Plug Isolations  
UK Offshore with Mac-Seal”*

# VR Plug Isolations with Mac-Seal 02

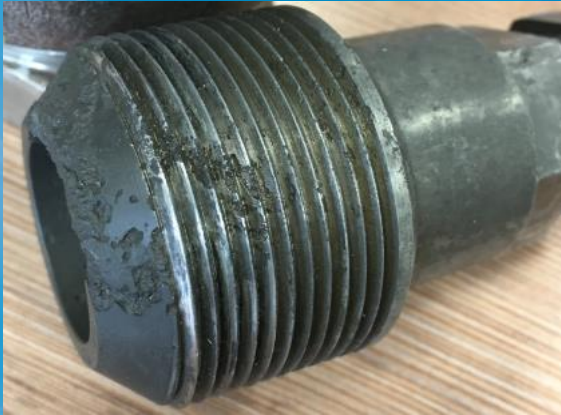
Corroded threads on VR Plug

- ❑ KCI were approached by a major Oil and Gas producer in the UK to provide isolations on several A-Annulus VR Plugs that had failed a leak off test on Gas Lift Wells.
- ❑ The Isolations were required to regain full Well Integrity on the selected wellheads.
- ❑ Corrosion had occurred on the VR Plug threads as seen on a sample recently recovered from a wellhead leading to a loss of integrity – see photo of corroded threads on VR plug.

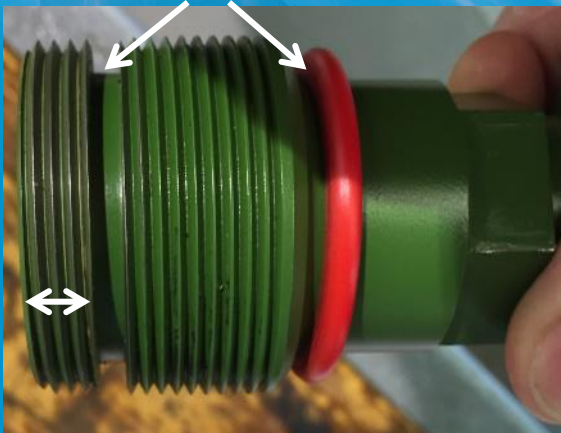
Seal ring fits in the groove

Mac-Seal 02 applied in front of seal

- ❑ The offshore operation followed on from a successful onshore trial where a corroded VR Plug coated with Mac-Seal 02 was installed into a test fixture which was progressively damaged to replicate the offshore leaks reported.
- ❑ A new style VR Plug with a Teflon ring will be used offshore along with Mac-Seal 02 to isolate the leak paths.
- ❑ A final pressure test or leak off test will be carried out to verify the isolation.

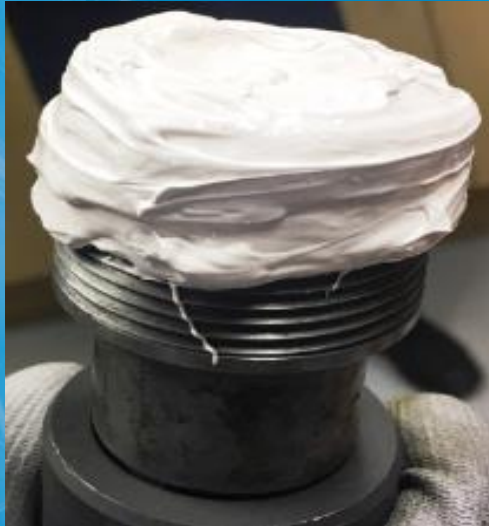
Mac-Seal 02 applied to VR Plug

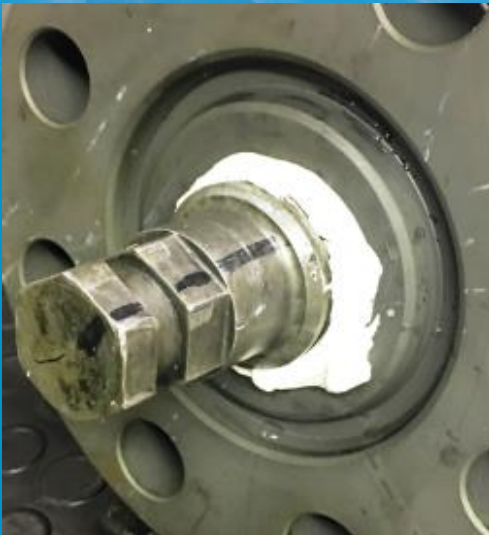
Original VR Plug installed into test piece with Mac-Seal 02
