KCI E-News Bulletin:

MAC-SEAL – Leak Sealing Solution

*“Successful Casing Hanger
Mandrel Isolation with Mac-Seal”*

Casing Hanger Mandrel Isolation - Mac-Seal

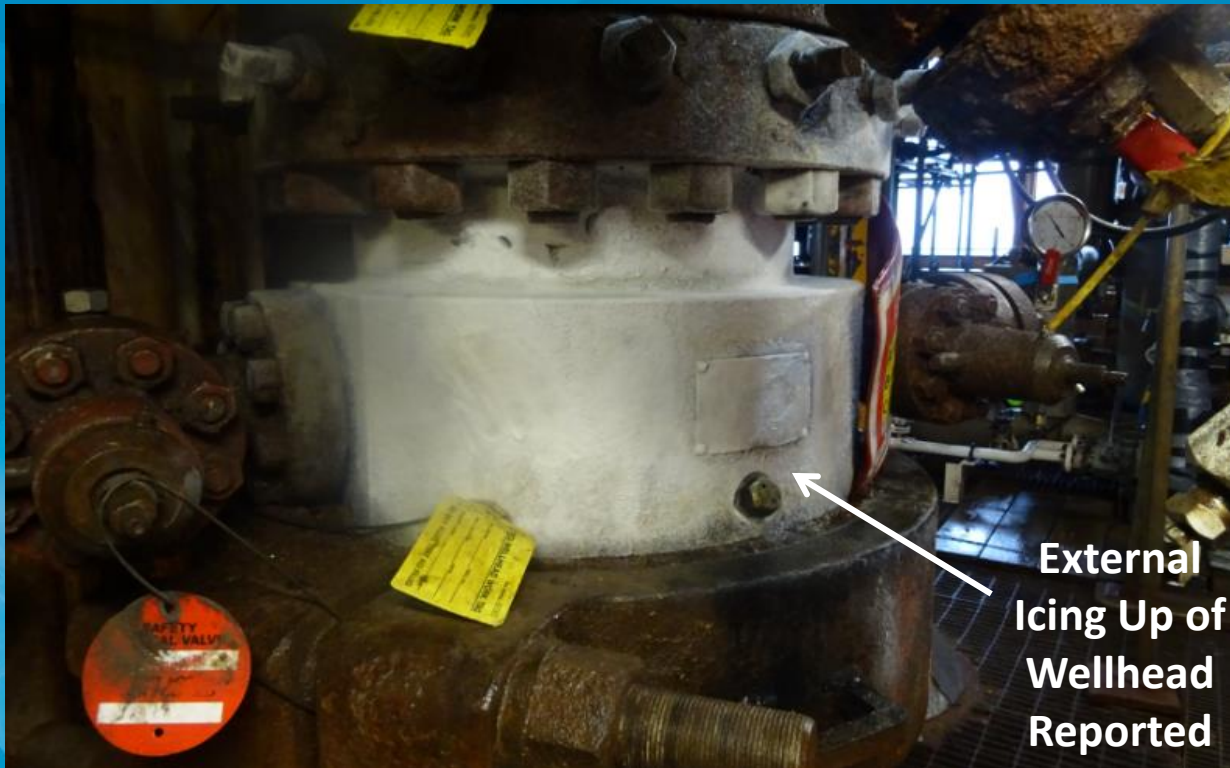
- ❑ KCI were asked by a major Oil and Gas producer to provide an isolation on a Vetco Wellhead due to A to B Annulus communication. The well is a gas lift design and the A Annulus gas pressure was charging the B Annulus.
- ❑ Severe freezing was witnessed at the 9 5/8" Casing Spool when venting down the B-Annulus indicating that there was a significant gas leak path causing the external icing on the wellhead.
- ❑ The Well was Shut-In due to this major Well Integrity issue.

- Test medium fluid was injected into the Casing Hanger assembly to confirm the leak path – leak verified.
- 1.8 Litres of Mac-Seal 02 was deployed into the 9-5/8" Casing Hanger Mandrel Void to establish the isolation.
- 0.5 Litres of Mac-Seal 01 (thinnest viscosity) was deployed to isolate the split or damaged BT Seal assembly.
- Once the Mac-Seal had cured the 9-5/8" Casing Hanger Mandrel Void was tested using A & B Annuli pressures.
- With full Gas Lift pressure on the A Annulus, the B Annulus was successfully vented off with no pressure build up or external freezing witnessed on the external body of the wellhead.
- The isolation was successful. The well was safely brought back online.
