MAC-SEAL Leak Sealing Solution

“Successful DHSV Line Isolation on a
UK Subsea Wellhead Using Mac-Seal”

3/8" DHSV Line Isolation using Mac-Seal

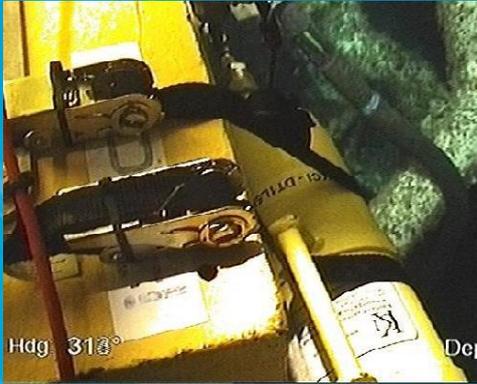
KCI's Deployment Tool on ROV

- The well was vented to reduce any back pressure and the leak path monitored.
- 1 litre of Mac-Seal was mixed and decanted into Deployment Tool on surface.

- The Deployment Tool was attached to the ROV, connected the Hot Stab and the hydraulic fluid input. The ROV was lowered to the worksite and latched onto the Tree Hot Stab.

- 1 litre of Mac-Seal was injected into the Feed Line in 6 minutes creating a 40ft plug to isolate the Feed Line from the well pressure.
- The Mac-Seal was fully cured in 8 hours.

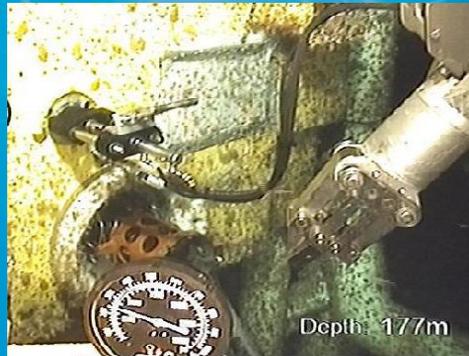
Deployment Tool fitted to Tree

- Once the Mac-Seal in the DHSV Feed Line had completely cured the isolation was pressure tested in direction of flow by raising the well bore pressure which is in communication with the DHSV Control Line at surface.

- A low pressure test of 300psi for 5 minutes - A Good test was achieved.
 - Raise the pressure in 300psi increments to 2,100psi.
 - A high pressure test of 2,100psi for 30 minutes - A Good test was achieved.
