MHS-Protect

“Successful Conductor Coating
on a UK Platform Using MHS-Protect”

Conductor Coating Using MHS-Protect

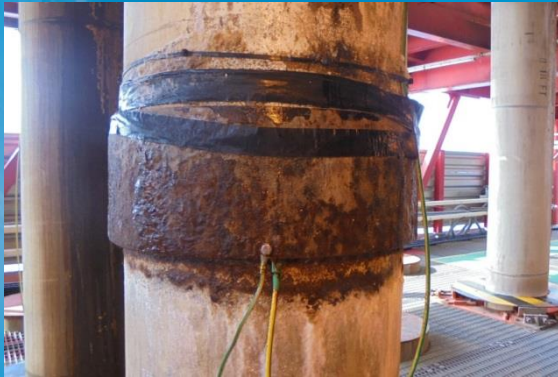
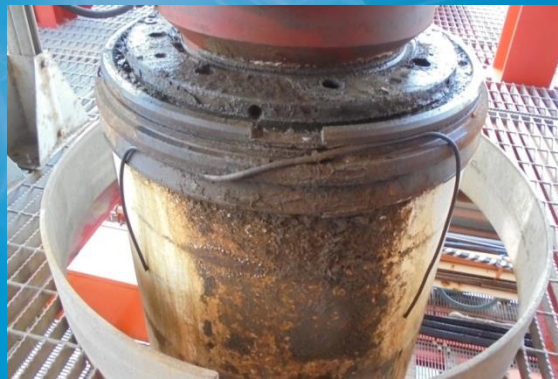
As found condition

- ❑ The surface coating on the Conductor Tops & Connectors is in poor condition . All items are showing signs of corrosion.
- ❑ Small weeps from the Well are present & salty fluids are running from the Wellhead down the Conductor creating this issue.
- ❑ KCI were requested to propose a solution for the prevention of further surface corrosion issues.
- ❑ KCI proposed a MHS-Protect coating applied by hand using a paint brush on the Conductor Connectors & at the Wellhead.
- ❑ KCI proposed MHS-Protect 04 (Standard Viscosity) for all of these applications.

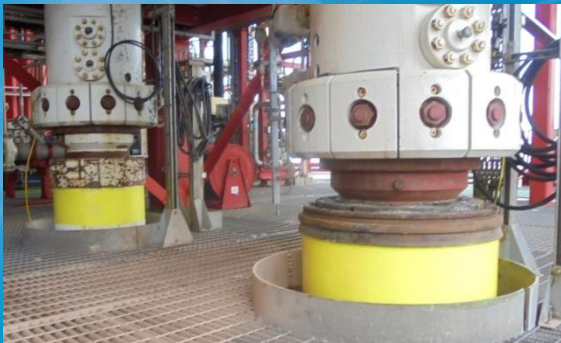
MHS-Protect Applied

- ❑ A Power Washer, Needle Gun, Wire Brush & K-Cleanse-100 (KCI Cleaning Fluid) were used to remove surface salt deposits & rust that had built up on & around the Conductors & Connectors.
- ❑ The areas to be treated were masked off to ensure that the sealant left a clean straight edge.
- ❑ Two coats of MHS-Protect were applied to the areas to create a robust coating to withstand the environmental conditions.
- ❑ All five Wellhead to Conductor & Connectors were successfully coated with MHS-Protect.

The Operation was successful and the Wellheads were protected as planned. Our customer was extremely satisfied with our Safe, Effective & Efficient application.

This Value Adding, Anti-Corrosion Operation prevented further corrosion occurring and saved the Well owner from a potentially time consuming Shot Blast & Painting work scope.
