“Successful Cable Transit Box Isolations  
on a UK Platform Using MD-Sealant”

## Cable Transit Box Isolation Using MD-Sealant

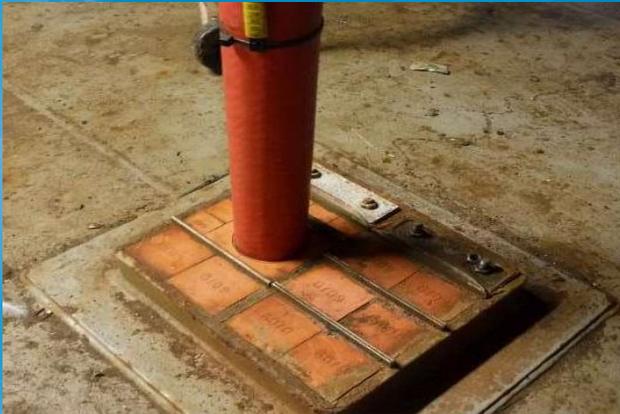
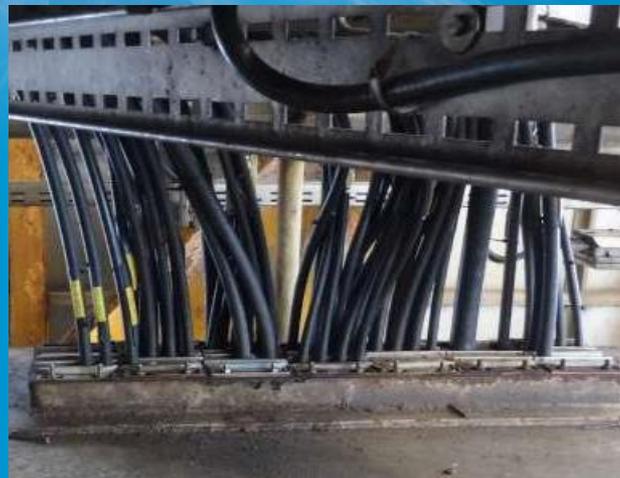
### As found condition

- ❑ Transit box was not compliant with customer operating criteria:
  - Water & Salt ingress into the Electrical Switch Room
- ❑ Leak discovered to be coming from the Rubber Blocks fitted in the Transit Boxes
- ❑ KCI were requested to propose a solution for the resolution for the fluid ingress
- ❑ KCI proposed a MD-Sealant coating applied using a paint brush and a large volume syringe for tighter areas to fill between the cables on the top of the Transit Box
- ❑ KCI used two different viscosities of MD-Sealant
  - ❑ MD-Sealant O4 (Standard viscosity).
    - For vertical areas
  - ❑ MD-Sealant O1 (Low viscosity)
    - To flow and seal around cables
