KCI e-news bulletin: Dec 2016

*“Successful DHSV Line Isolation on a
UK Subsea Wellhead Using Mac-Seal”*

3/8" DHSV Line Isolation using Mac-Seal 02

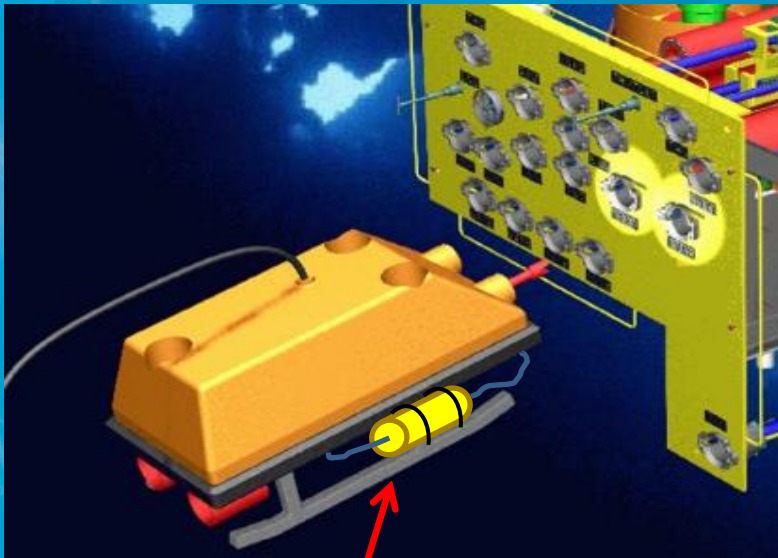
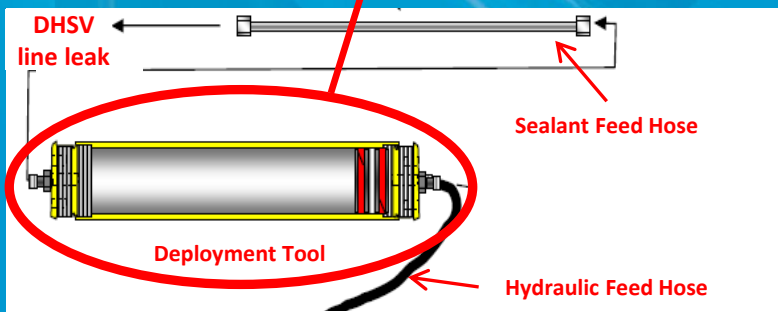
**KCI Deployment Tool
attached to ROV**

- ❑ The well was vented to reduce any back pressure and the leak path monitored.
- ❑ 1 litre of Mac-Seal 02 (bespoke formula) was mixed and decanted into a Deployment Tooling on surface.

- ❑ The Deployment Tooling was attached to the ROV structure, connected the Hot Stab and the hydraulic fluid input. The ROV was lowered to the worksite and latched onto the Tree Hot Stab.

- ❑ 1 litre of Mac-Seal 02 was injected into the Feed Line in 6 minutes creating a 40ft plug to isolate the Feed Line from the well pressure.
- ❑ The Mac-Seal 02 was fully cured in 8 hours.

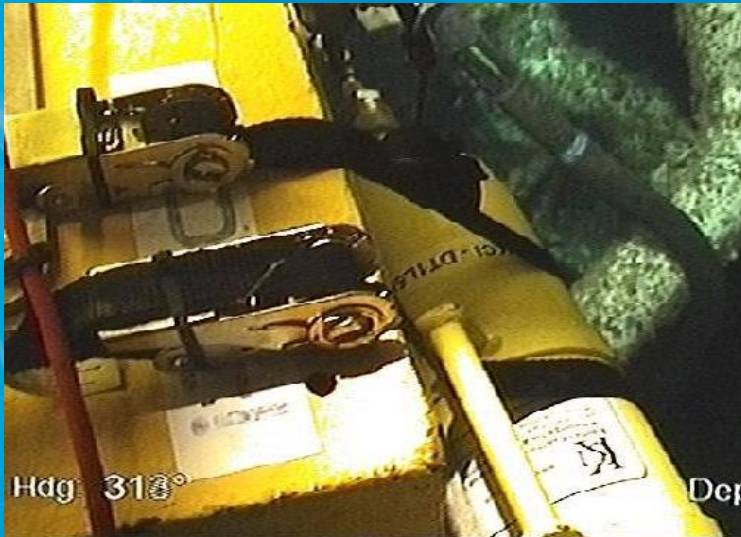
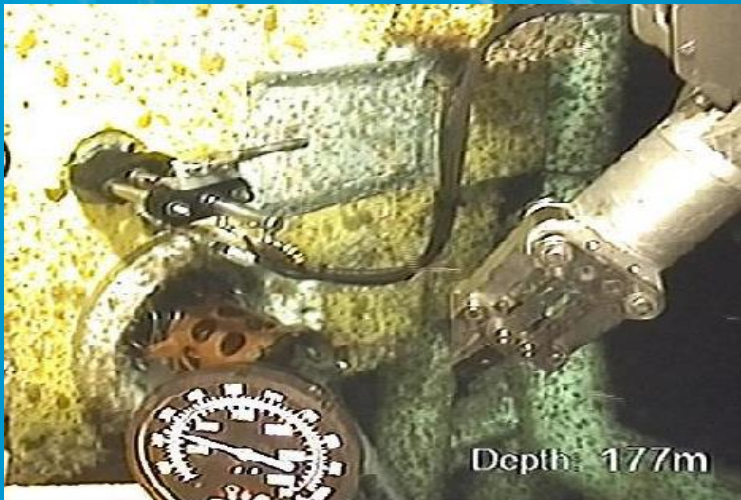
Deployment Detail

- ❑ Once the Mac-Seal in the DHSV Feed Line had completely cured the isolation was pressure tested in direction of flow by raising the well bore pressure which is in communication with the DHSV Control Line at surface.

- ❑ A low pressure test of 300psi for 5 minutes - Good test.
 - ❑ Raise the pressure in 300psi increments to 2,100psi.
 - ❑ A high pressure test of 2,100psi for 30 minutes – Good test.

- ❑ Positive pressure test on the isolated DHSV Feed Line confirmed - No leaks.
- ❑ Second pressure test carried out 24hours later – Good test.
- ❑ Mac-Seal isolation successful.
