MAC-SEAL Leak Sealing Solution

“Successful VR Plug Isolations
UK Offshore with Mac-Seal”

VR Plug Isolations with Mac-Seal

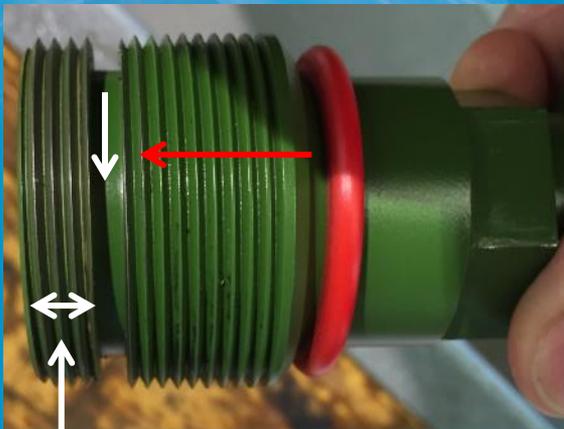
Seal ring fits in the groove of new VR plug

Mac-Seal applied in front of seal

- ❑ Four wells had their leaking VR Plugs removed and replaced.
- ❑ A new style VR Plug c/w Teflon Seal Ring was used along with Mac-Seal to isolate any leak paths.
- ❑ Mac-Seal was mixed and coated on the front four threads of the new style VR Plug then it was installed in the wellhead profile.
- ❑ Mac-Seal is designed to fill & isolate all corroded areas of the threads or any leak paths as the VR Plug is screwed into position and torqued up.
- ❑ The Mac-Seal was allowed to cure then a 3000psi pressure test was applied. A Good Test was achieved.
- ❑ The wells were brought on to production after the platform shut down with full gas lift pressure and no leaks were witnessed. A Good Test was achieved.

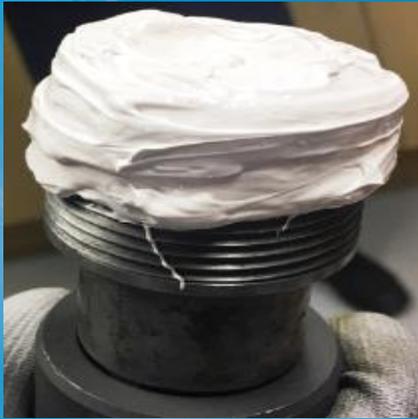
*Mac-Seal applied to VR Plug

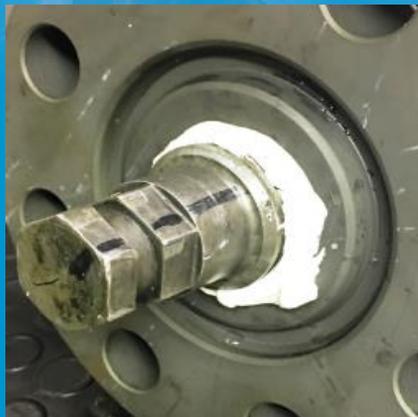
*Original VR Plug installed into test piece with Mac-Seal

*Example photos taken during successful onshore trial

- ❑ The offshore operation followed on from a successful onshore trial where a corroded VR Plug coated with Mac-Seal was installed into a test fixture which was progressively damaged to replicate the offshore leaks reported.
- ❑ A new style VR Plug with a Teflon ring will be used offshore along with Mac-Seal to isolate the leak paths.
- ❑ A final pressure test or leak off test will be carried out to verify the isolation.
