IBS & MS-Sealant Leak Sealing Solution

“Successful Rigless Hybrid Wellhead Isolation
In South East Asia Using IBS & MS-Sealant”

Rigless Wellhead Hybrid Isolation using IBS & MS-Sealant

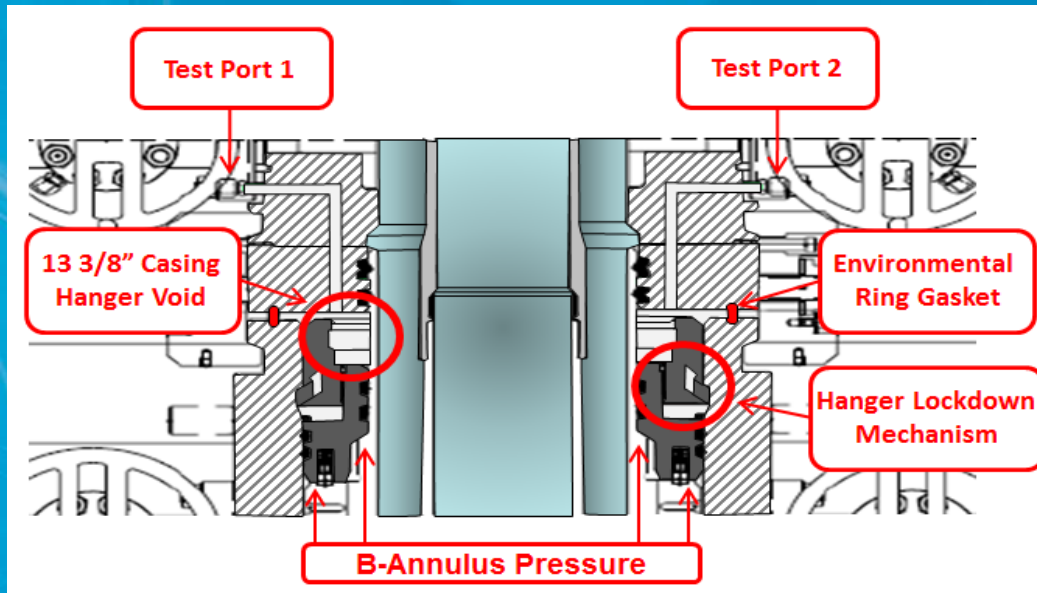
- ❑ KCI were asked by a Major Oil and Gas Operator in South East Asia to provide an isolation to prevent the B-Annulus pressure entering the 13 3/8" Casing Hanger Void.
- ❑ During KCI's evaluation process the leak was verified. The B-Annulus pressure was vented from the Casing Hanger Void and it built up to full B-Annulus pressure overnight.
- ❑ This test was carried out twice with the same result verifying the failure.
- ❑ A standard Sealant deployment operation was not suitable for its application as the Casing Hanger Locking Mechanism must be protected to ensure it can be recovered at a later date. IBS-S was used to safeguard the moving parts as it can be broken back to fluid for a trouble free Hanger recovery operation.
- ❑ The Well was shut-in due to this serious Well Integrity issue.
