MAC-PAC Leak Sealing Solution

*“Successful Isolation of Downhole Safety Valve
Packing Stack using Mac-Pac”*

Otis WRDHSV with B-Seals & Swellable 'O' Rings Stack

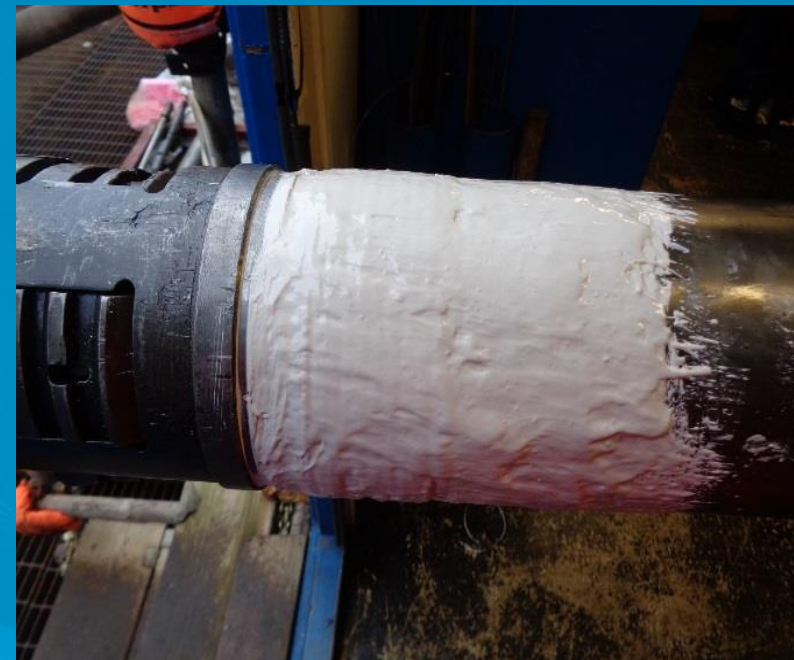
Mac-Pac Applied at surface

- ❑ 500mls of Activated Mac-Pac Sealant applied to the Upper and Lower Seal Stacks. (See picture below)
- ❑ The Lower Packing Stack will squeeze through the Upper Seal bore depositing some sealant into the damaged areas. The Upper & Lower Packing Stacks will then enter their corresponding Seal Bores at the same time.
- ❑ The sealant below the Upper Packing Stack will start to engage and smear onto the Seal Bore filling all corroded or damaged areas.
- ❑ Once the Mac-Pac cured the customer obtained a good pressure test on the Control Line and Inflow test on the Safety Valve retaining full functionality.
